Jorgensen Forge Outfall Site Quality Assurance (QA) Daily Report Form

Date: 16 September 2015

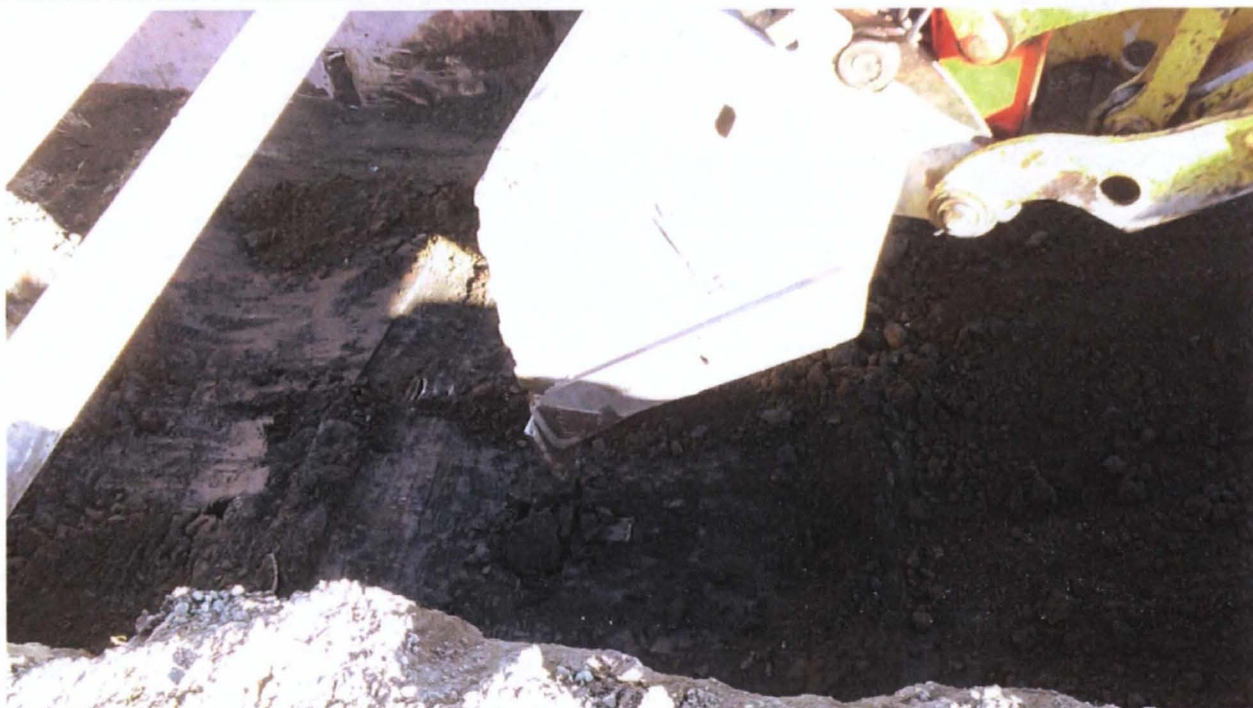
Photo 1: Subtitle D excavation.

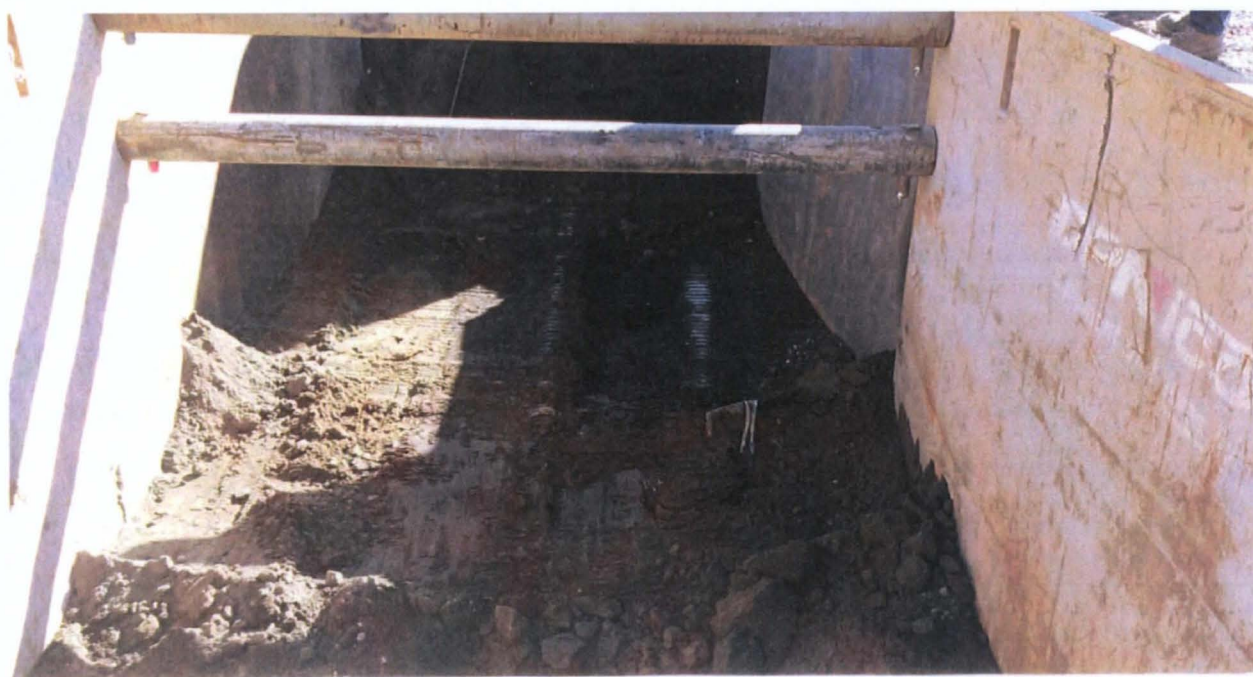
Photo 2: 12 inch and 24 inch CMP top of pipe exposed

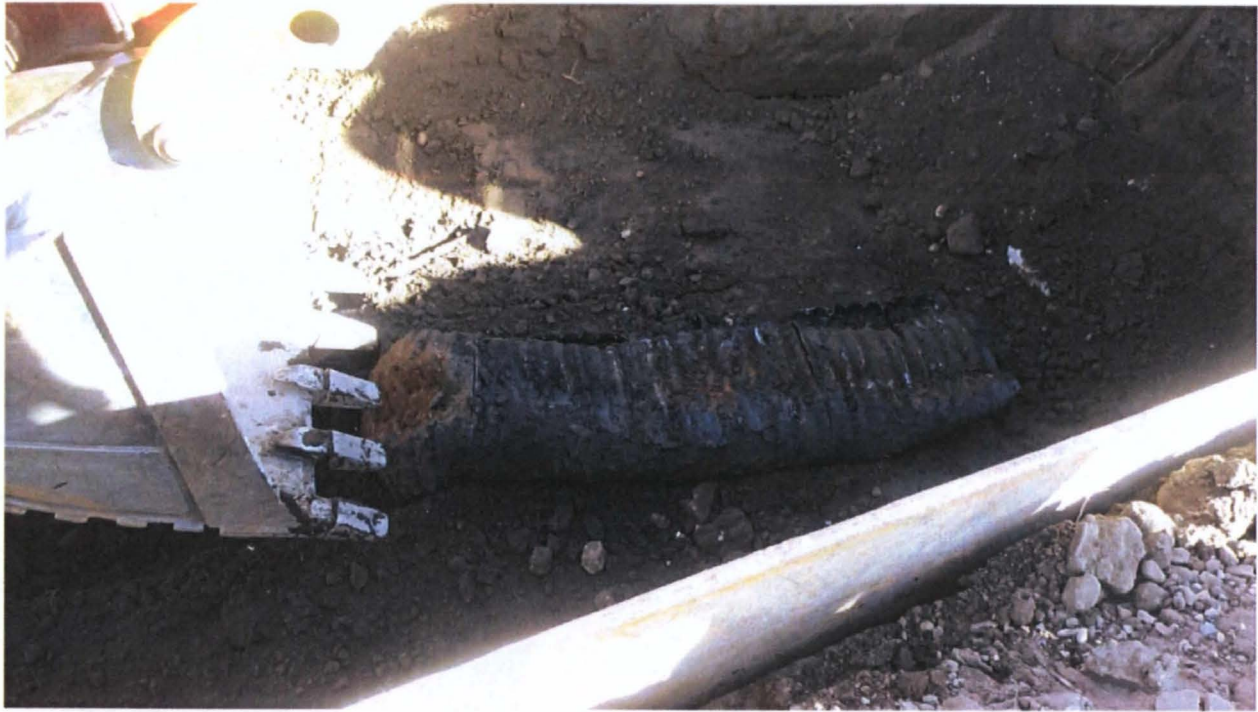
Photo 3: 12 inch CMP removal

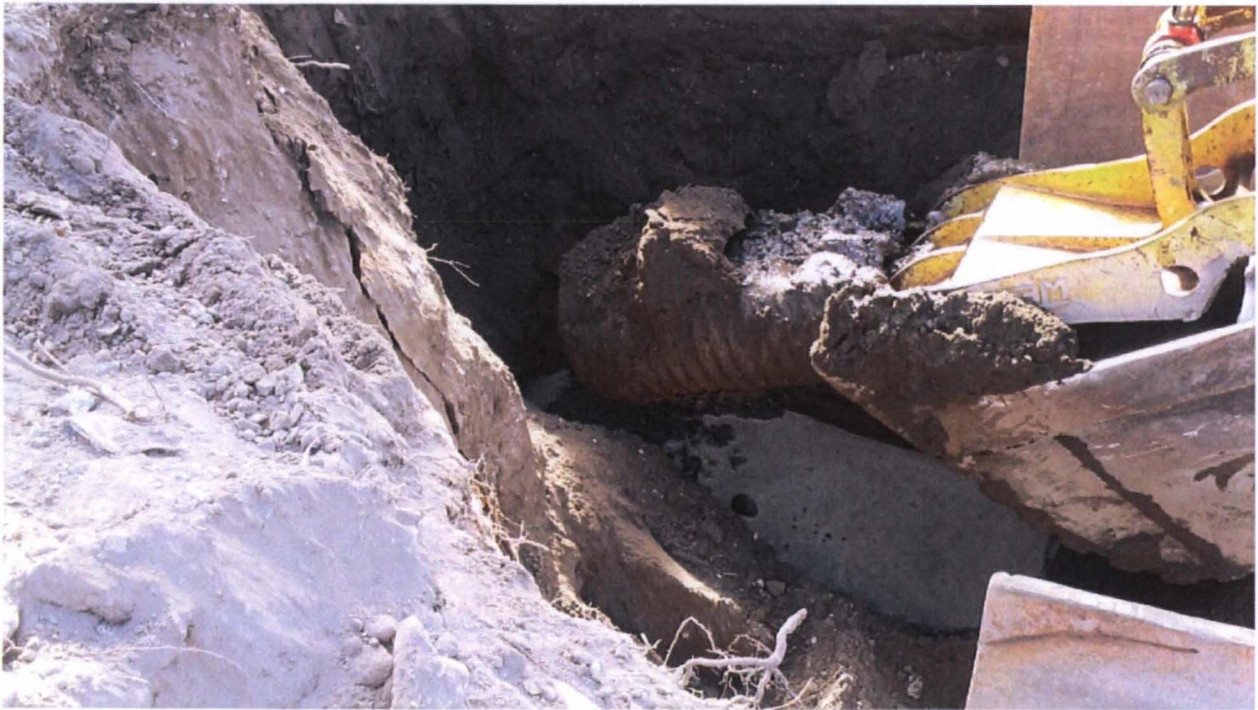
Photo 4: 24 inch CMP Removal

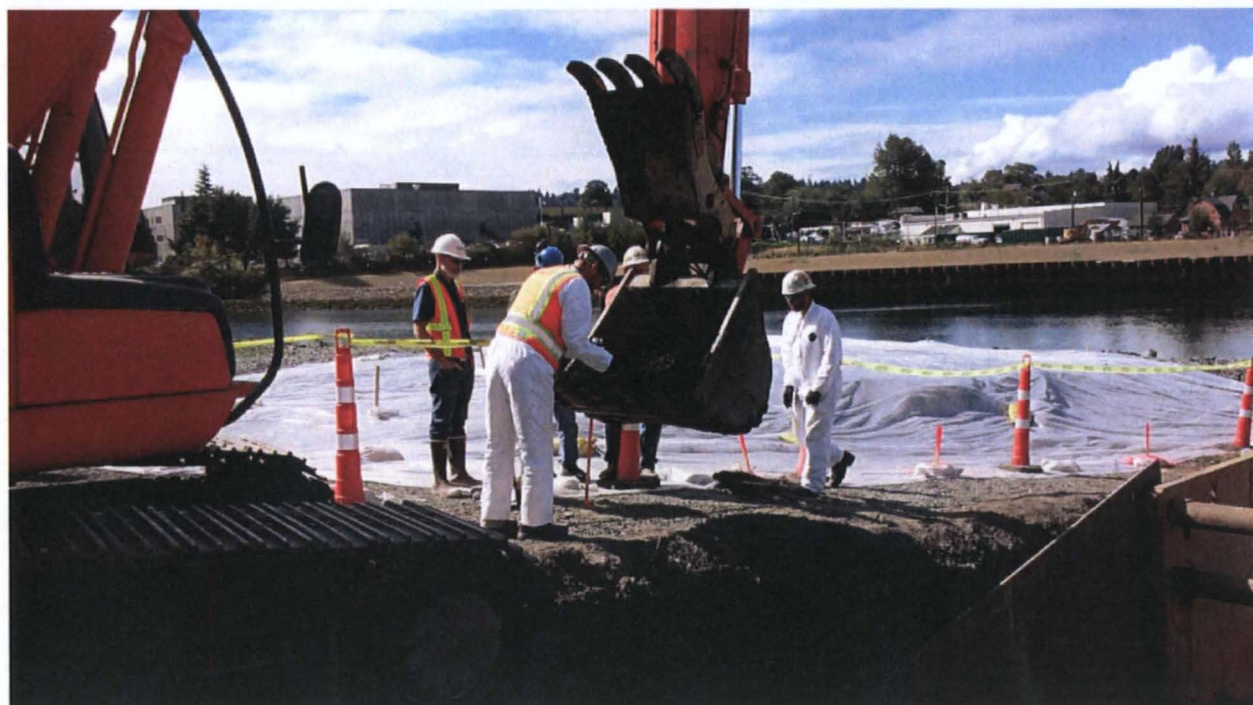
Photo 6: First sample taken from excavator bucket to ensure safety

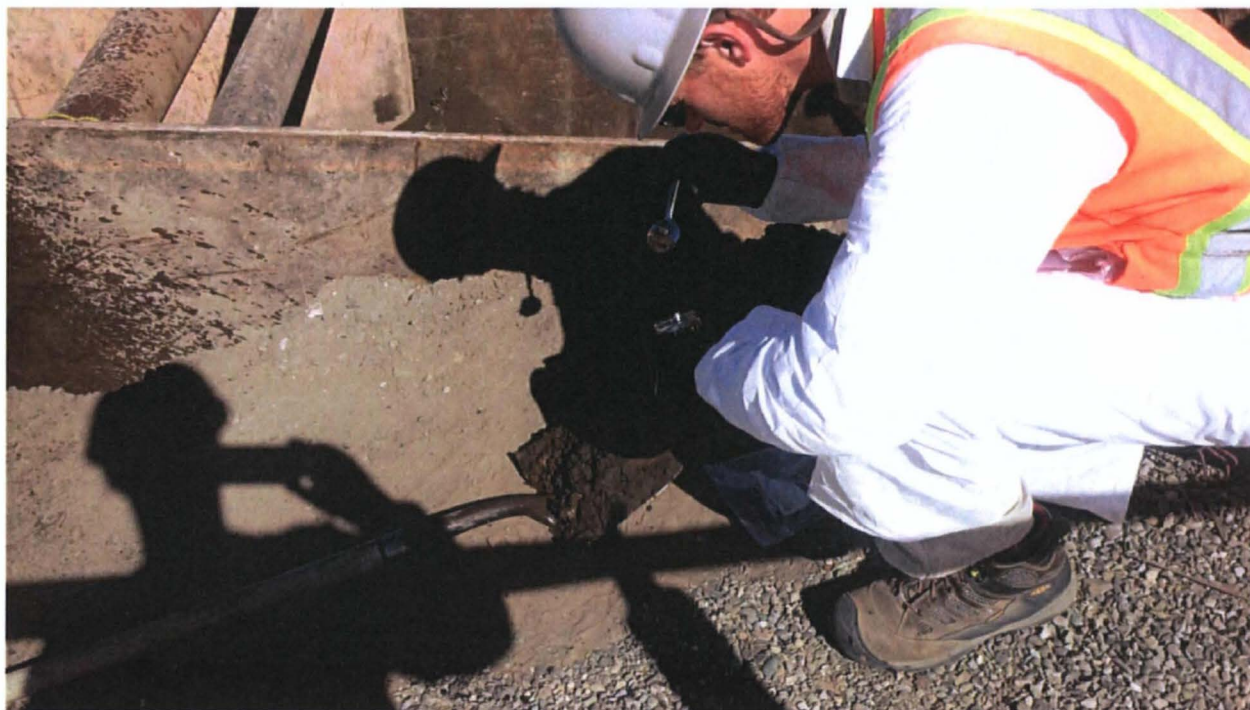
Photo 7: Second soil sample taken from shovel. This shovel scoop was able to be taken from inside the trench box.
